## SINT AGNIETENKLOOSTER (founded in 1420)

Agnietenklooster Museum, *Elburg, NL*

- ***Apus apus* colony monitoring**
- **Birdstones measurements**
- **Birdstones catalogue**

June 27-28, 2026.

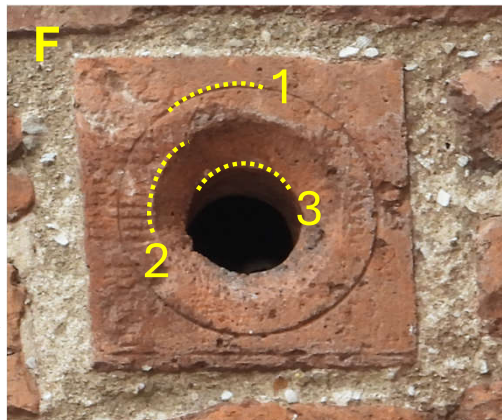
**BIRDSTONE** →  
 1- decorative circle (engraved)  
 2- Outer diameter of the access hole  
 3- Inner diameter of the access hole:  
 only this is useful for the target species

**Birdstones** (see image F) appear to be of the same external size (about 11x15 cm) covering a space of two brick and plaster on top of the other but those used for the Cross seem wider. On each **birdstone** the holes seem to have been made **manually** by cutting a section of cone (F,2), wider outside, perhaps of decorative effect enhanced by an engraved circle (F.1; not always present or preserved), which opens on the external surface with a very large and decidedly variable section in diameter that narrows inwards for the inner diameter (F,3; the real access hole) to the cavity, generally more stable in diameter (for about 2 cm deep). See image G for an interesting comparison with a **spreeuwenpot**.

- **the diameter of the holes (F,3)** in the innermost part seems to be stable at around **5 cm** in quite all the façades and **also in most of the Cross**, as documented in the medieval Flemish widespread **spreeuwenpot** (birdpots for starlings); moreover, the shape of the entrances of these birdstones resembles those of a modern replica (see F) in use in Leuven (B);

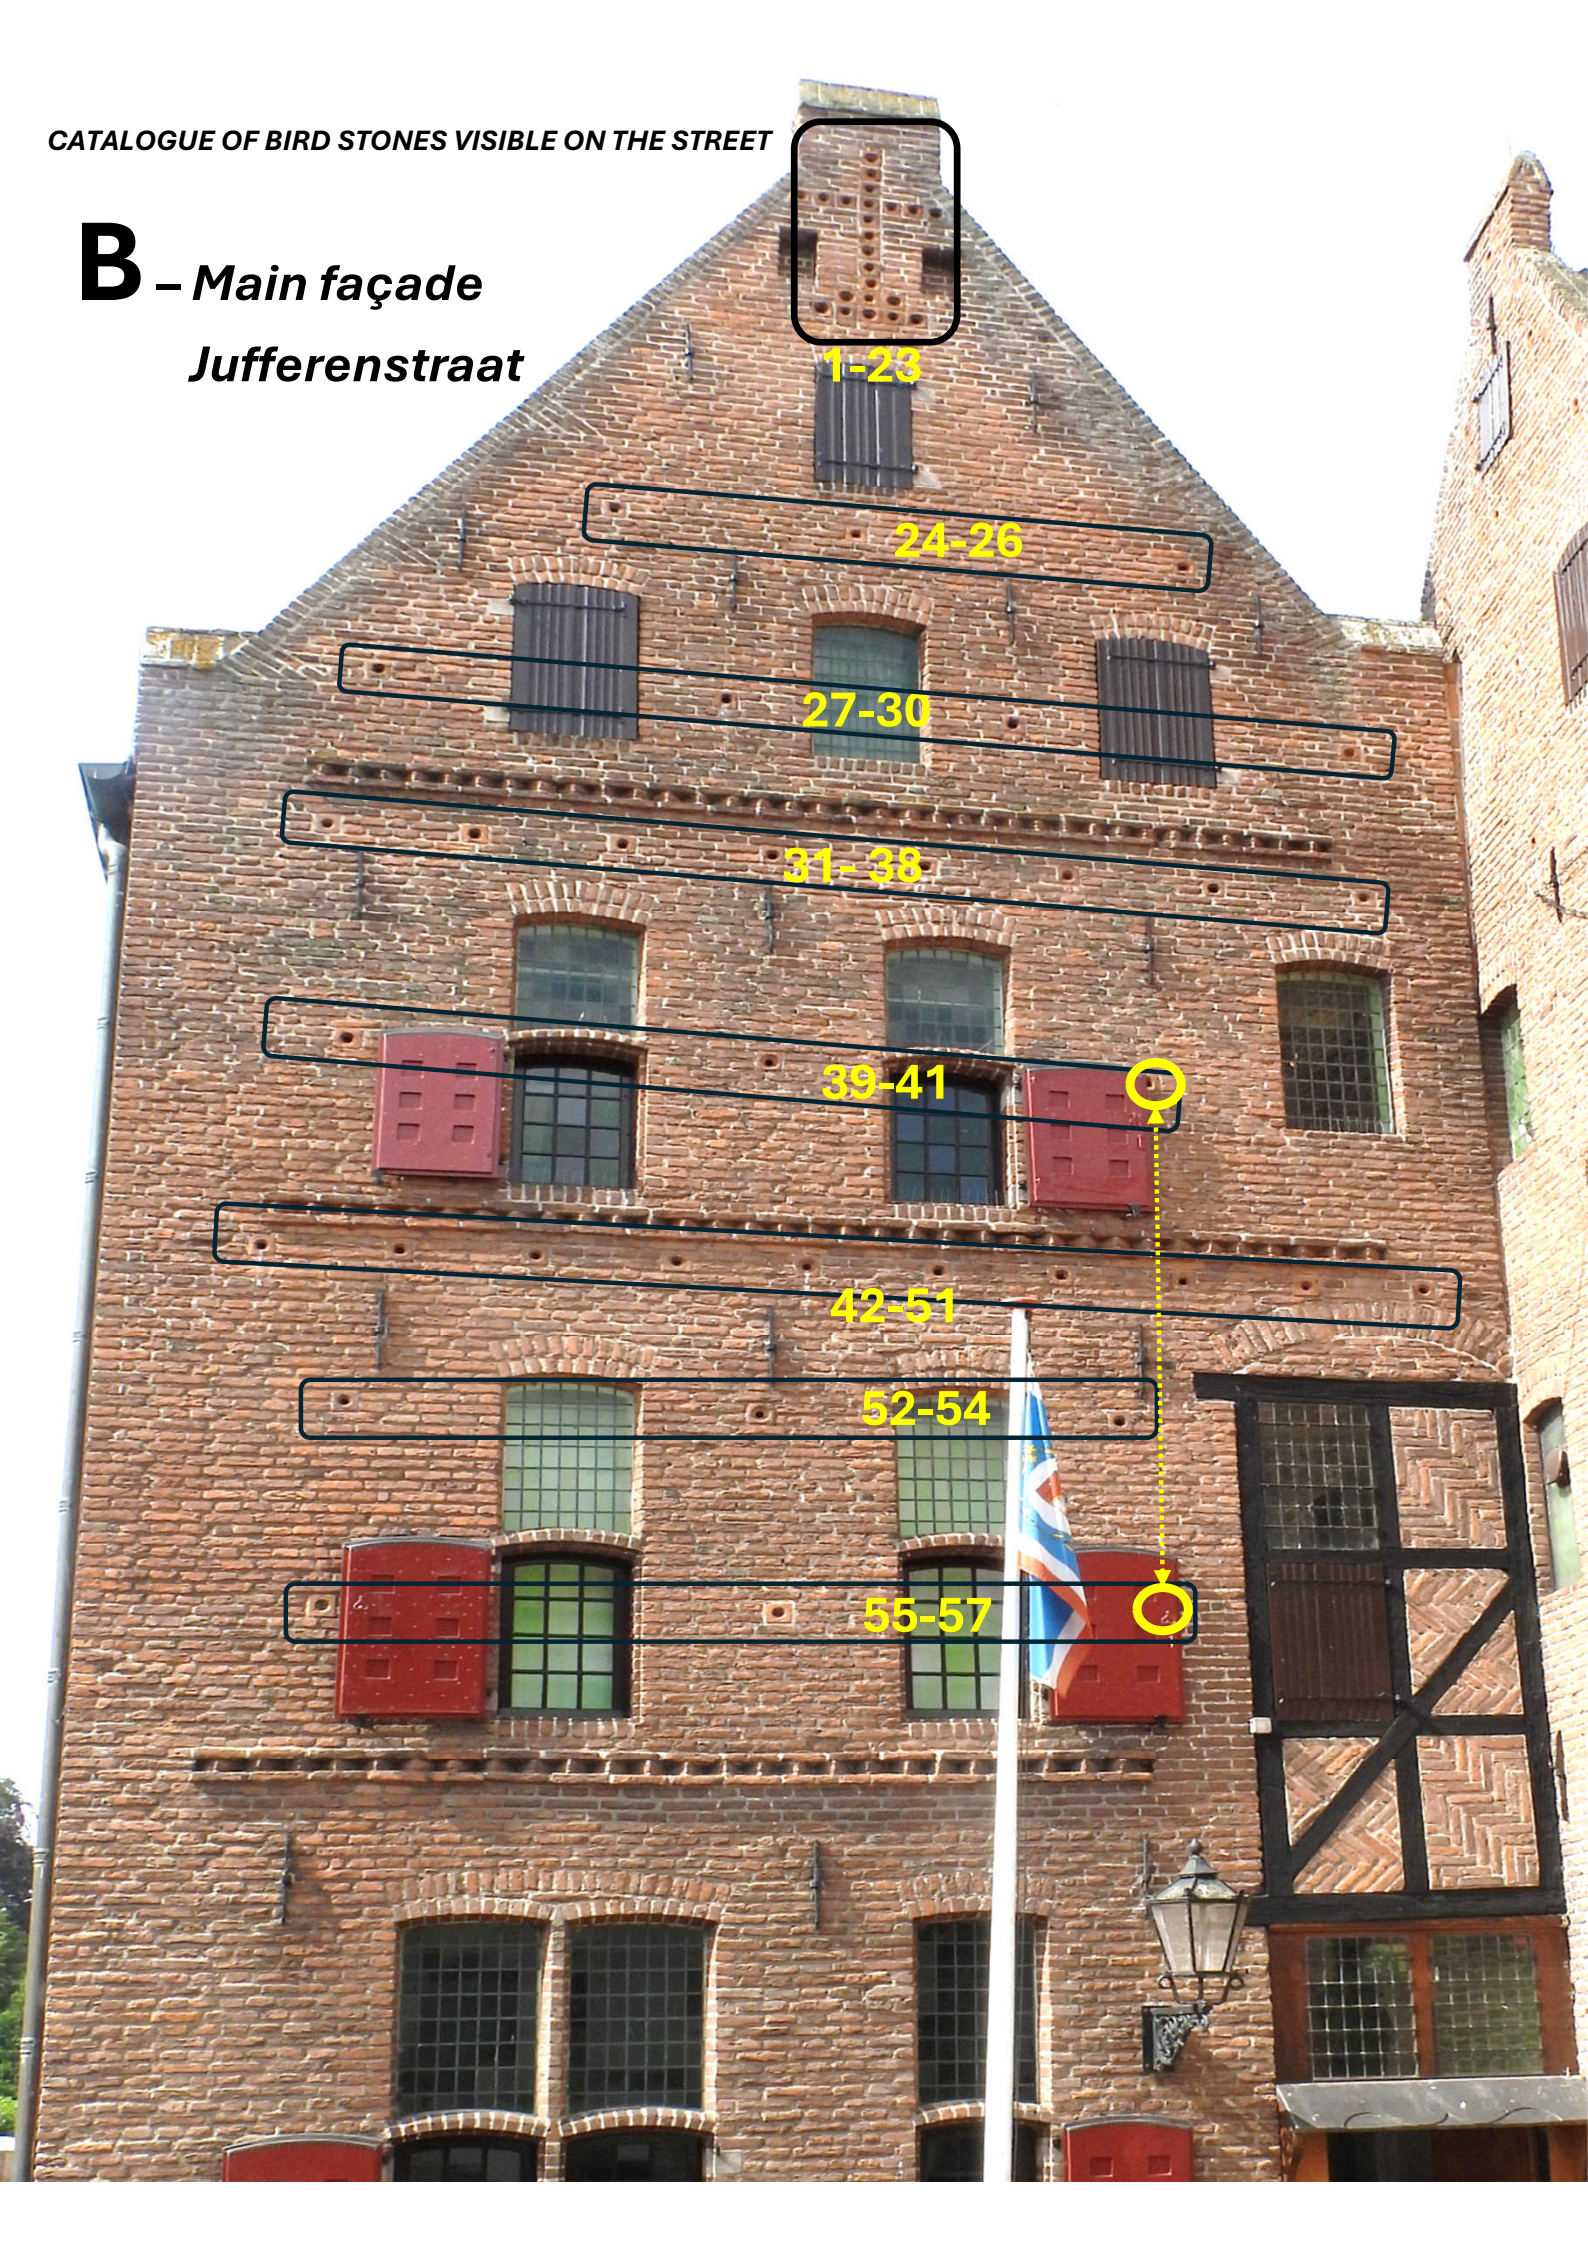
# B – Main façade

Jufferenstraat

1-23

24-26

27-30

31-38

39-41

42-51

52-54

55-57
